Safety Alert

A Publication of PPL Services Safety Operations

Date: November 16, 2010

Alert Type: Safety Message Handling MITC Fume Treated Poles

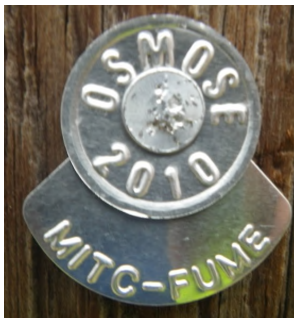
Osmose Corporation is treating PPL poles with a product called **MITC Fume**, a wood preservative pesticide to control wood rot and decay-causing fungi. MITC Fume is a solid/crystallized chemical in an aluminum tube placed into bored holes at the base of a pole, one foot below ground line to three feet above ground line. The solid/crystallized chemical turns to gas (activated by heat) and completely dissipates over a period of approximately four years. When the tubes are sealed and contained within wood poles, they are not a hazard to the environment, the public, or anyone working around the pole. If tubes are damaged or exposed, they pose a potential health risk and special handling is required. A photo of a MITC Fume tube is shown below:

The primary hazard associated with exposure to the crystals within the MITC Fume tubes is dermal contact. Impermeable gloves, i.e. nitrile or similar shall be worn to prevent contact to this substance. Wear goggles, safety glasses or a face shield to protect the eyes. Avoid inhalation of MITC FUME vapors. Do not handle the tubes in an enclosed space.

If possible, the aluminum tubes should be picked up remotely (with tongs, pliers or similar tool) and placed back in the pole. **If this is not possible, STOP. Proceed using the following instructions:**

- Don protective impermeable gloves and safety glasses or face shield for eye protection.
- Pick up the tubes remotely (with tongs, pliers or similar tool) and place into a separate container that can be sealed.
- Transport the sealed container and tubes back to the Service Center. Do not carry the container in the passenger compartment of the vehicle.

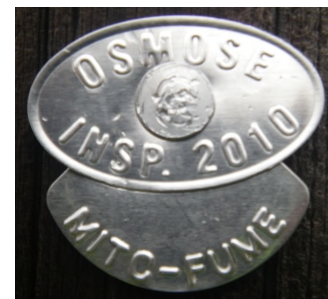
Poles inspected and treated with MITC Fume tubes are marked with metal tags by Osmose. One tag will identify Osmose and the year the inspection took place. A second tag will be applied noting the type of fumigant used, i.e. MITC Fume, etc. These tags are placed five to six feet above ground level on the road side of the pole. Examples of this tagging method are displayed. The tag on the left notes that the pole was fully excavated and treated with MITC. The tag on the right notes that the pole was inspected and treated with MITC.
